MICROSCOPIC EXAMINATION OF STEEL

HENRY FAY, Ph. D., D. Sc.

*Professor of Analytical Chemistry, Massachusetts Institute of Technology
Consulting Metallurgist, Watertown Arsenal*

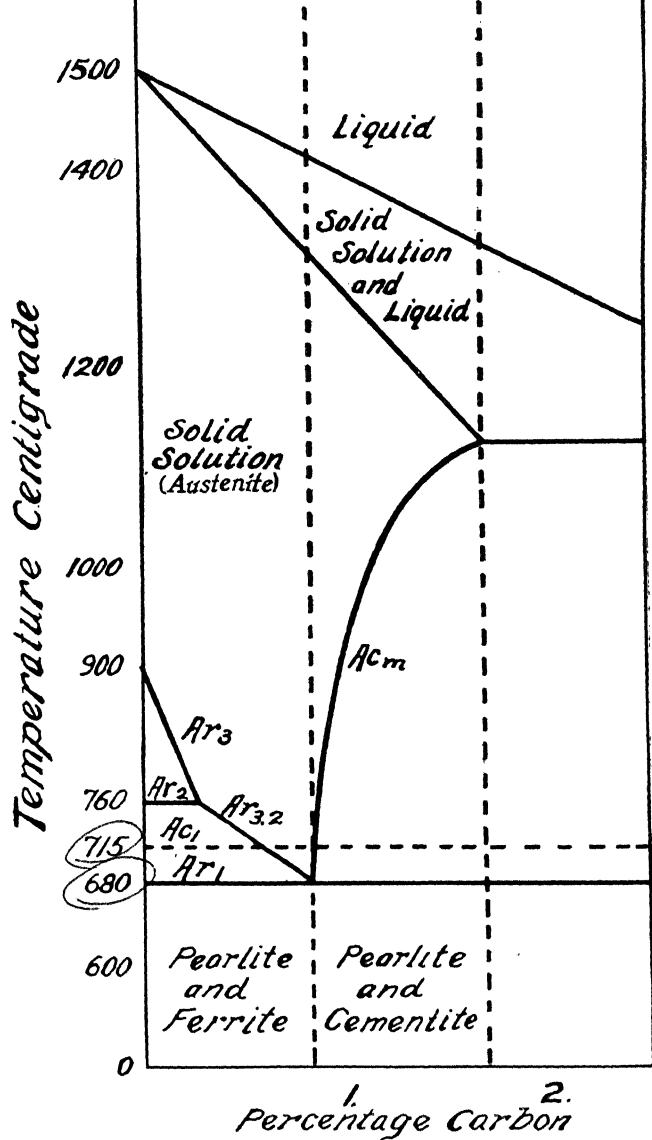
Fig. 1

Portion of iron-carbon diagram

constituents, iron and iron carbide. The Ac_1 point is approximately 30° higher than the Ar_1 point, and represents the beginning of the formation of solid solution. In steels containing 0.85 per cent carbon there is but one critical temperature at which the solid solution decomposes into its constituents, iron and iron carbide. This is known as an eutectoid steel, and its microscopic constituent is pearlite. Pearlite always etches dark, and under high magnifications is shown to consist of alternate laminations of iron and iron carbide. Steels containing less than 0.85 per cent carbon are hypoeutectoid, and contain the microscopic constituents ferrite and pearlite, the amount of the latter increasing with the per cent of carbon. Steels containing more than 0.85 per cent carbon are hypereutectoid, and contain the microscopic constituents cementite (iron carbide, Fe_3C) and pearlite. These facts are illustrated in the diagram. (Fig. 1.)

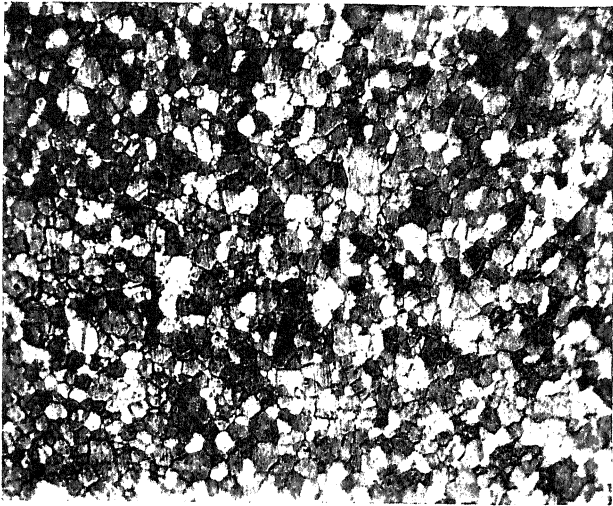
PHOTOGRAPH NO. 1. X75.

0.06% carbon. Approximately pure ferrite.

Photograph No. 1 shows the characteristics of a carbonless iron in which the whole field is made up of granules of ferrite. With the introduction of carbon there is a decrease in the amount of ferrite and the constituent pearlite begins to appear. This is shown in photograph No. 2 for a steel containing 0.18 per cent carbon. Inasmuch as steels containing 0.85 per cent carbon contain 100 per cent pearlite, and as pearlite is composed of ferrite and cementite, in this steel containing 0.18 per cent carbon there ought to be approximately 20 per cent of the field made up of pearlite. In a steel containing 0.5 per cent carbon there should be 58.8 per cent pearlite. Such a steel is shown in photograph No. 4. A eutectoid steel containing 0.83 per cent carbon and practically 100 per cent pearlite is shown in photograph No. 7. Under higher magnifications pearlite shows the laminated structure shown in photograph No. 8. In hypereutectoid steels the excess carbon beyond that necessary to form pearlite, separates as free cementite and the amount of free cementite can be calculated. Inasmuch as the whole field is made up of pearlite

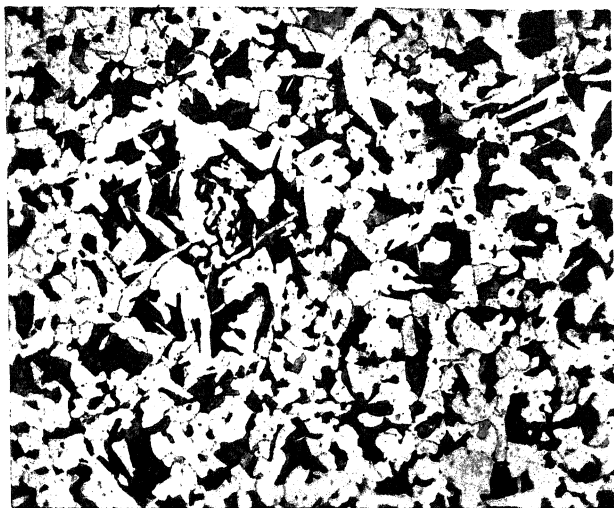
PHOTOGRAPH NO. 3. X75.

0.32% carbon. Ferrite (white) and pearlite (dark).

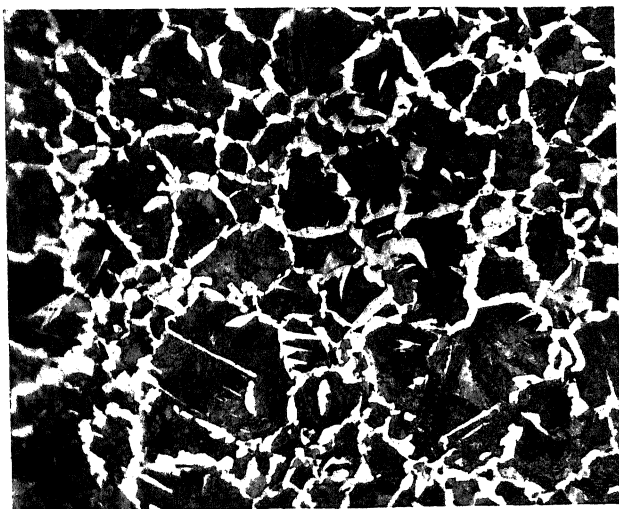
PHOTOGRAPH NO. 4. X75.

0.49% carbon. Ferrite (white) and pearlite (dark).

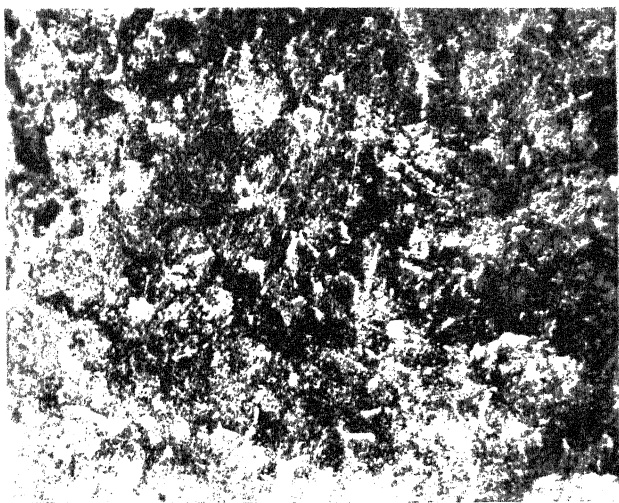
PHOTOGRAPH NO. 6. X75.
0.71% carbon. Ferrite and pearlite.

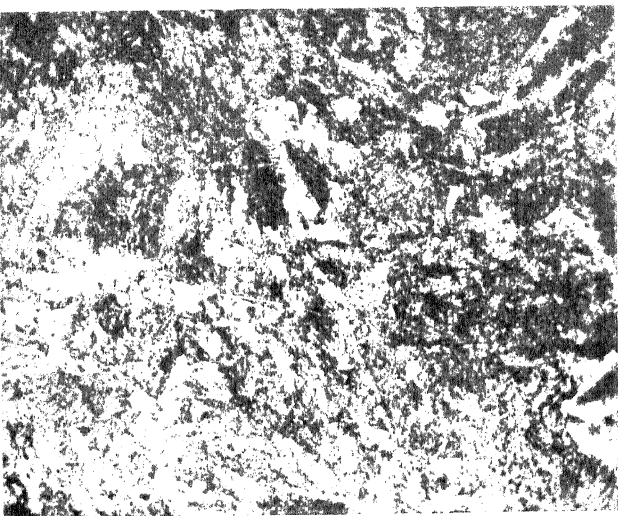
PHOTOGRAPH NO. 7. X75.

0.83% carbon. Pearlite.

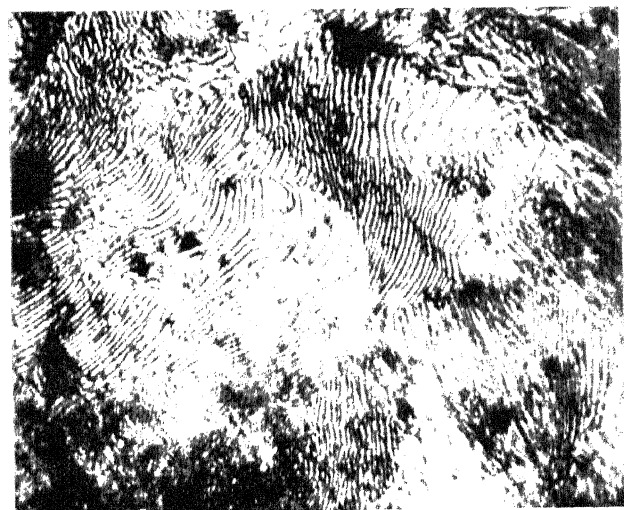
PHOTOGRAPH NO. 11. X485.

0.83% carbon. Pearlite.

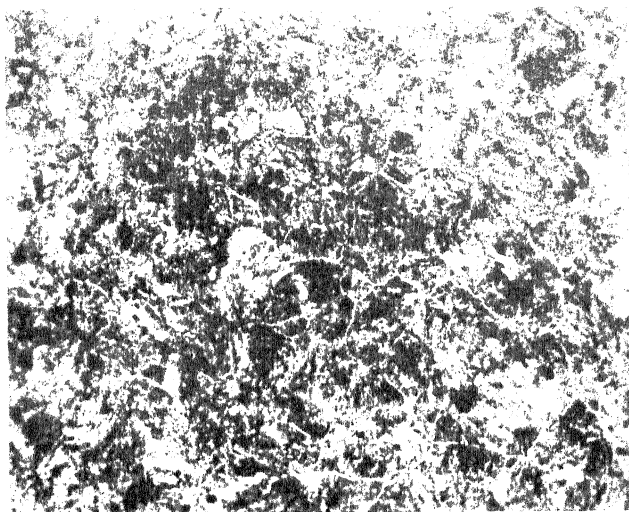
PHOTOGRAPH NO. 9. (X75,
1.22% carbon. (Pearlite and cementite (white).

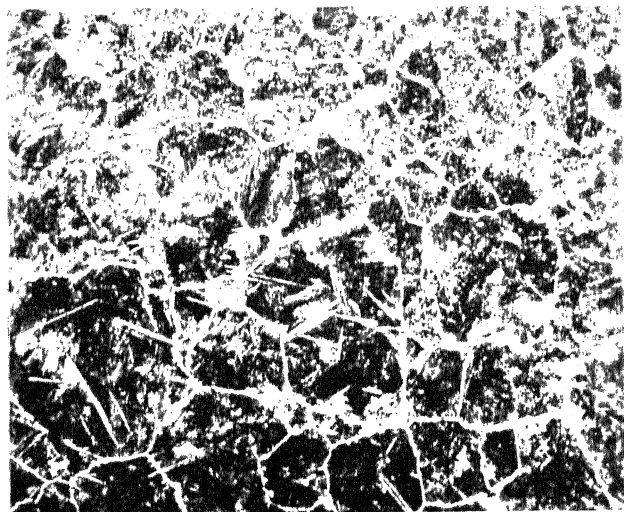
PHOTOGRAPH NO. 10. (X75,
1.46% carbon. (Pearlite and cementite (white).

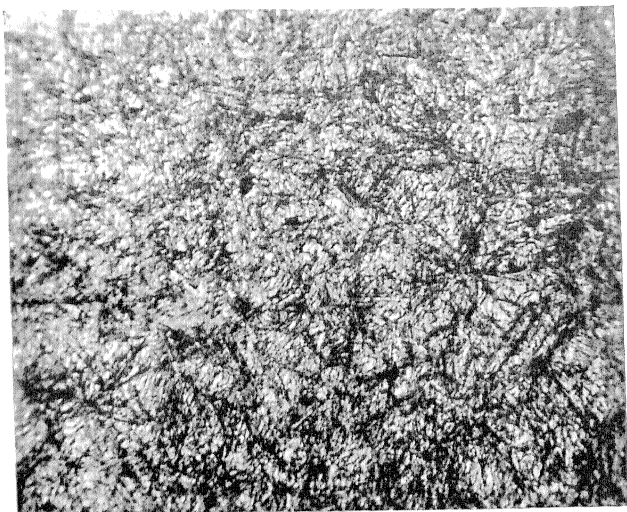
PHOTOGRAPH NO. II. X75.

Martensite.

Photograph No. 11 shows the characteristic appearance. Commercially martensitic steels are unimportant on account of their extreme brittleness and they are found only rarely.

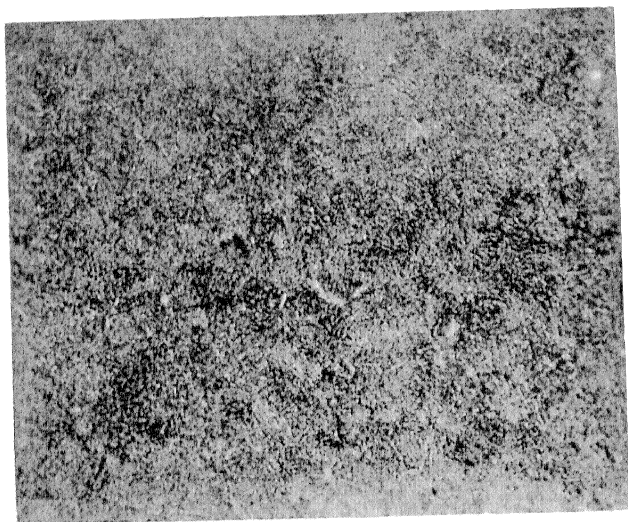
PHOTOGRAPH NO. 12. X75.

Troostite.

If heated to temperatures below A_{c1} , the effect produced will vary with the temperature. The lower the temperature of re-heating the smaller is the tendency toward stable equilibrium; the higher the temperature the more stable is the product produced. Practically any degree of hardness may be produced, varying from glass-hard to extreme softness, by properly regulating the temperature of the heating. There are then two extremes, the martensitic steels formed by quenching from above A_{c1} and the pearlitic steels formed by cooling slowly from A_{r1} or above. Intermediate between these extremes are steels in which more or less of the unstable solid solution has been partly converted to more stable forms. Such forms are represented microscopically by troostite and sorbite. Troostite, formed by tempering at relatively low temperatures, represents the first stage in the breaking down of the unstable equilibrium and is characterized by the amorphous or slightly granular structure. Etching with alcoholic nitric acid the surface usually blackens immediately from separated carbon. Photograph No. 12 shows troostite.

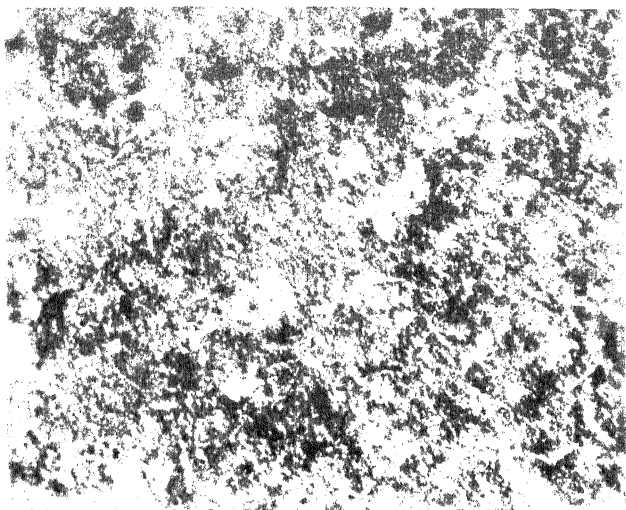
PHOTOGRAPH NO. 13. X75.

Sorbite.

Sorbite steels are those which have been quenched and heated to a higher temperature and thus represent a more stable state of equilibrium. They are characterized by having a peculiar yellowish color, and the structure is better defined than troostite. The particles of iron carbide have not assumed definite lamellations with ferrite as in pearlite, but are very much more distinct than in troostite. Photograph No. 13 shows sorbite.

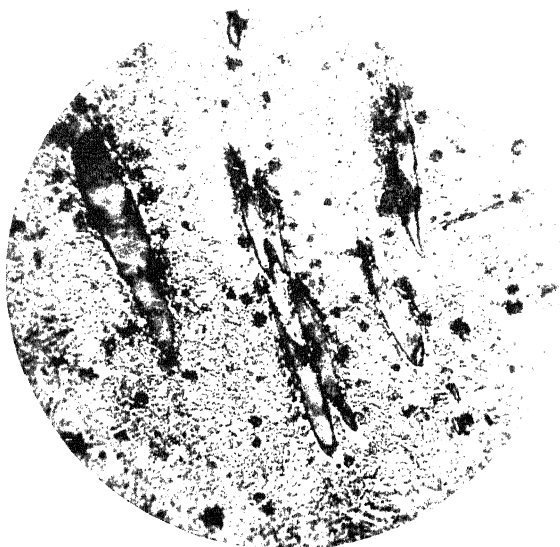
PHOTOGRAPH NO. 16. X50.

Sulphide of manganese in gun steel.

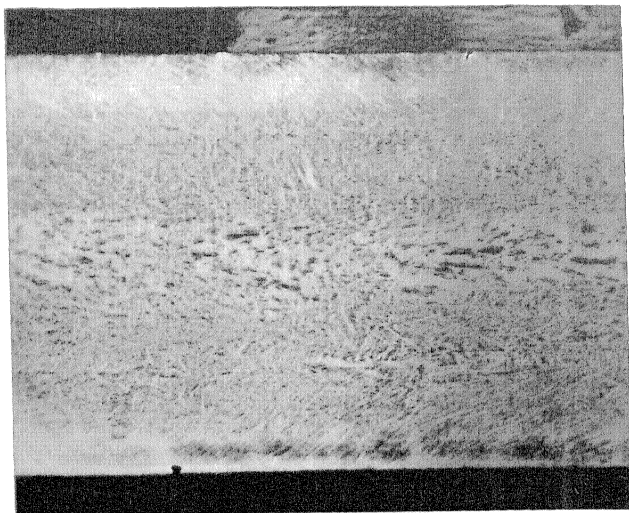
PHOTOGRAPH NO. 19. ONE-THIRD SIZE.
Ingot structure in steel.

The presence of ingot structure such as shown in photograph No. 19 indicates that the heat treatment and forging have not been sufficient to wipe out the crystallization which occurred on the solidification of the metal. It is not definitely known that the presence of ingot structure is harmful, and it is frequently accompanied by excellent microstructure, but it serves as an indication of the heat treatment to which the metal has been subjected after solidification. It is believed that such a structure would not be found in the best steel, and it is further believed that metal showing ingot structure would be more liable to rupture from shock than metal in which the ingot structure had been wiped out by heat treatment and forging.

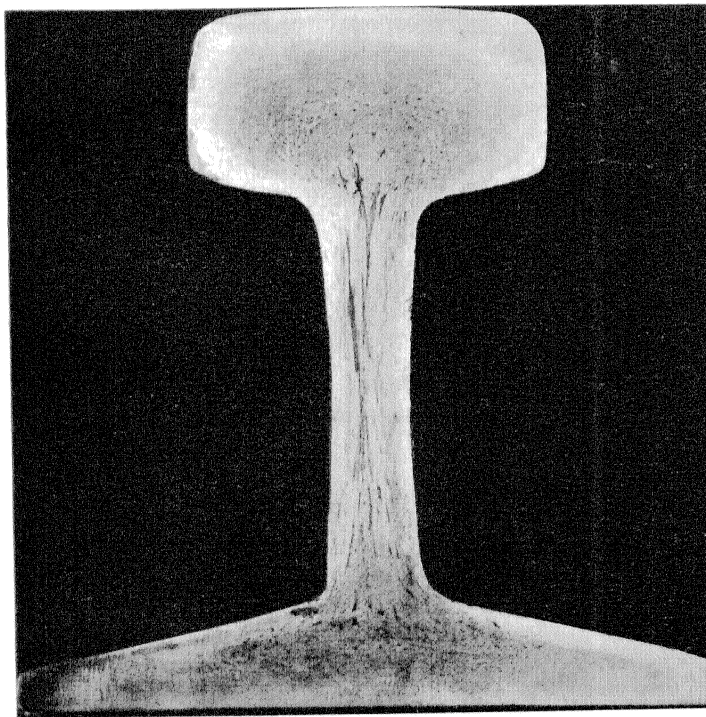
PHOTOGRAPH NO. 20.
Cross section of steel rail showing segregation in center of head, web, and base.

Segregation of carbon or phosphorus may be brought out most successfully by etching a complete cross section of the metal under investigation, such as shown in photograph No. 20 of a rail section in which segregation of carbon is shown, or in photograph No. 21 of a cross section of a piece of cold-rolled shafting

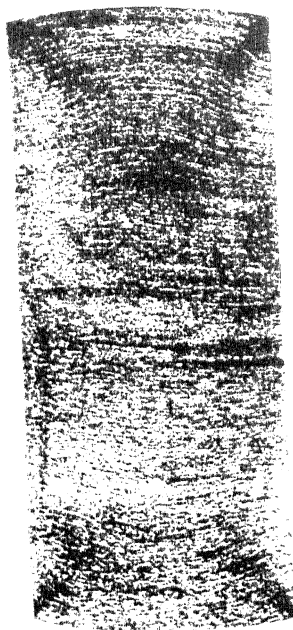
PHOTOGRAPH NO. 23.

Area of strained metal brought out by etching with copper ammonium chloride.

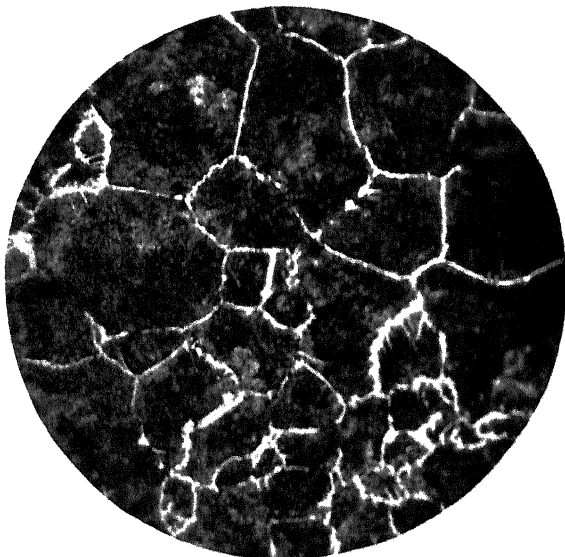
PHOTOGRAPH NO. 30. X75.
Coarse microstructure in gun steel.

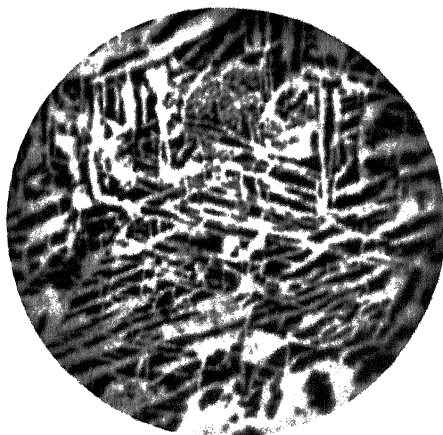
PHOTOGRAPH NO. 31. X50.
Crystalline structure in cast steel.

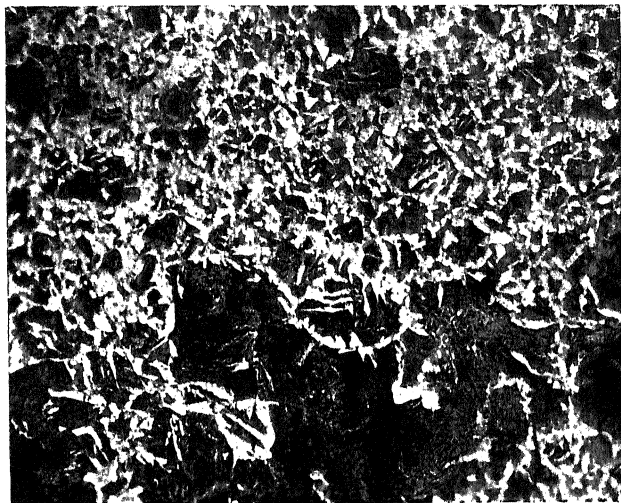
PHOTOGRAPH NO. 32. X75.

Microstructure showing incomplete heat treatment.

Failure to obtain uniformity of structure is shown in photograph No. 32. Discussion of photographs Nos. 49, 51, and 53 will be found under the discussion of some of the special cases, viz., the failure of 14-inch gun lever arm. Dangerous overheating is shown in photograph No. 33. In this case the material is burnt, as is shown by the oxide between the granules of pearlite.

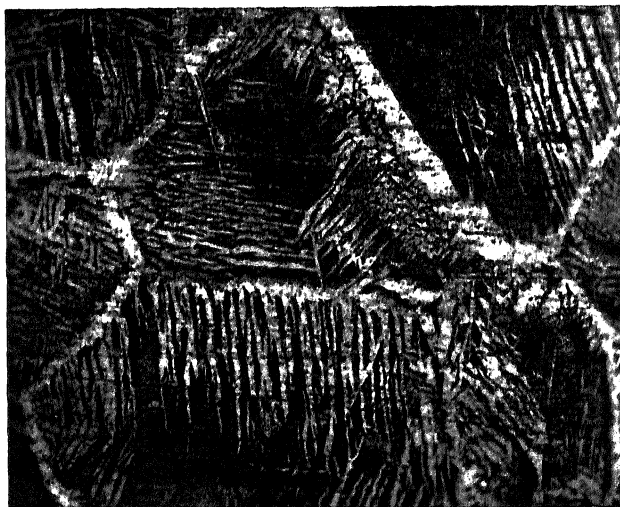
PHOTOGRAPH NO. 33. X75.

Microstructure of overheated steel.

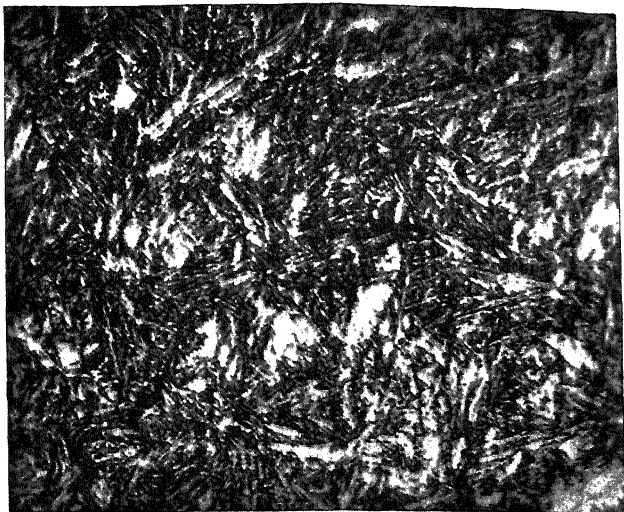
PHOTOGRAPH NO. 34. X500.

Microstructure of forging which had been originally martensitic, and in tempering this structure has not been completely eliminated.

observed that the original martensitic structure is completely removed by the tempering process. This point is illustrated by photograph No. 34 in which there are distinct remains of the original martensitic structure. Such a steel properly heat treated ought to show a structure similar to photographs Nos. 12 or 13.

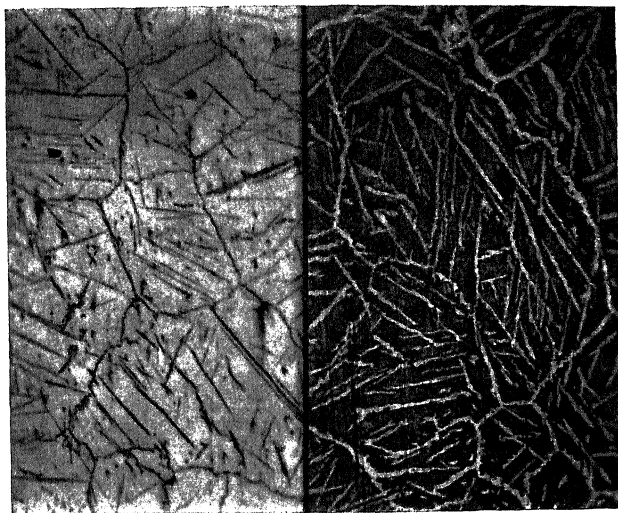
PHOTOGRAPH NO. 35. X65.

Microstructure in center of broken recoil spring showing excess cementite, indicating high carbon. Left, white lines are cementite etched with nitric acid solution; right, dark lines are cementite etched with sodium picrate solution.

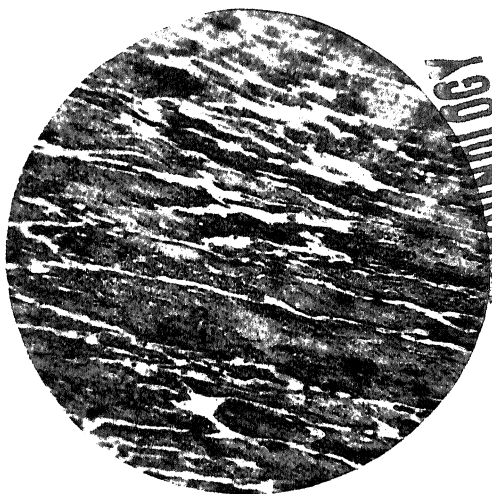
PHOTOGRAPH NO. 36. X50.

Microstructure of steel subjected to cold work, and
showing distortion of grain.

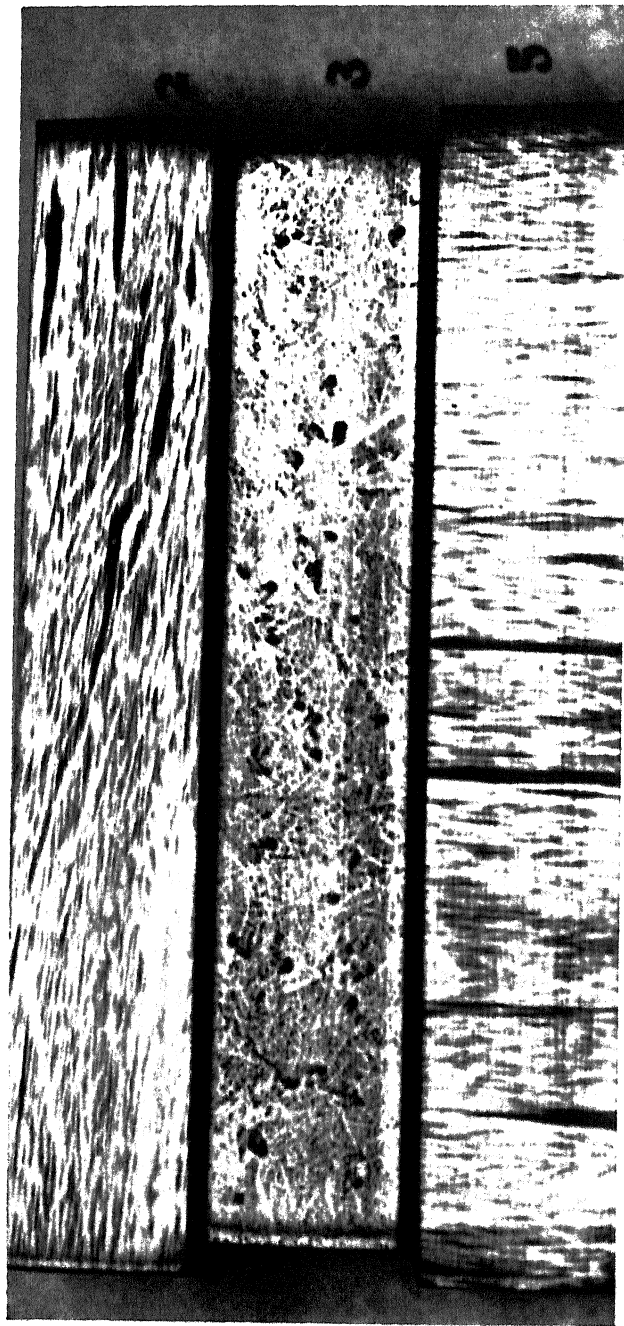
PHOTOGRAPH NO. 38.

Macrostructure of test bars of 10-inch pipe showing surfaces cut longitudinal 5, radial 3, and tangential 2 to axis.

Photographs Nos. 38 and 39 show the macrostructure of the steel when etched with iodine, the specimens shown in photograph No. 38 being taken longitudinally, radially, and tangentially. The segregation of phosphorus is indicated by dark lines in pieces Nos. 2 and 5 of photograph No. 38 and in pieces 3 and 4 of photograph No. 39 and by the dark spots in piece 3. Photograph No. 39 shows the metal cut from the region of the fracture and treated in the same manner, as shown in piece marked 5 in photograph No. 38, and in other pieces not shown. The dark streaks were found to be elongated parallel to the direction of forging, and it is reasonable to assume that the elongation will always be parallel to the surface of the metal forged. By inspection of the two larger pieces of metal from the region of the crack (photograph No. 39) it will be seen that there is considerable distortion of the phosphide area

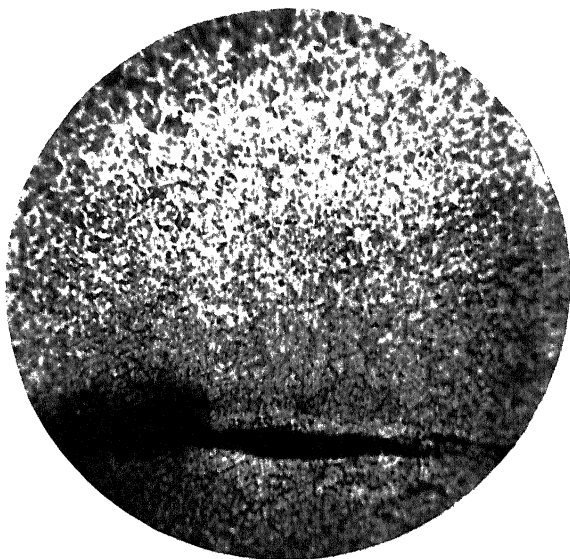
PHOTOGRAPH NO. 40. X50.

Crack and slag, with decarbonized area in 10-inch rifle.

Examination of sections in the vicinity of the crack showed many fine cracks, slag inclusions, and carbonless areas. The cracks led to slag, and where the slag was found there were also found decarbonized areas. Photograph No. 40 shows a crack ending in slag and surrounded by decarbonized iron. The course of the slag was quite irregular, as shown in photographs Nos. 41 and 42.

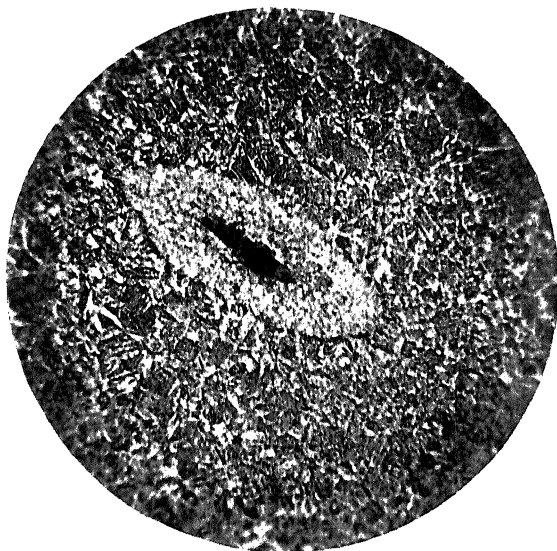
PHOTOGRAPH NO. 44. X50.

Island of slag in decarbonized area in 10-inch rifle.

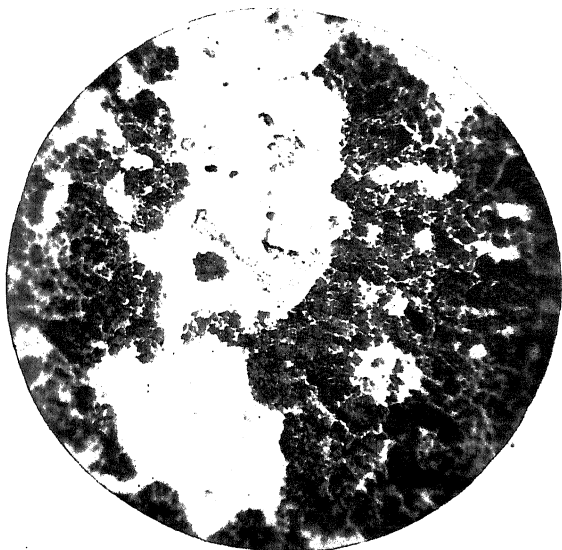
PHOTOGRAPH NO. 46. X50.

Fourteen-inch gun lever. Segregated ferrite (white) with slag inclosures.

This lever was made of cast steel and was broken during the test of the carriage. A microscopic examination revealed the structures shown in photographs Nos. 46 to 51, inclusive.

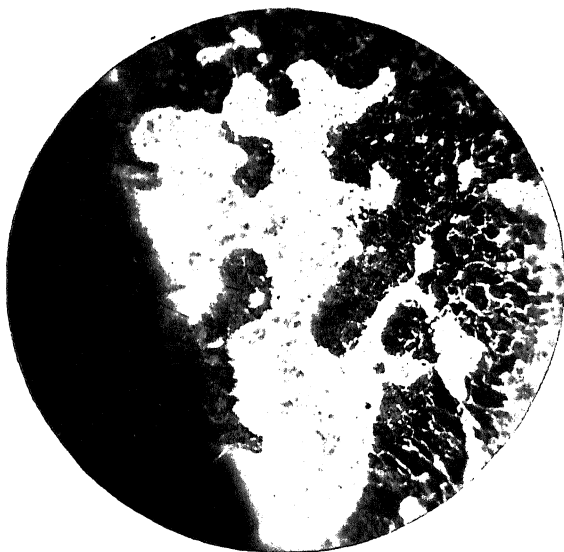
PHOTOGRAPH NO. 47. X50.

Fourteen-inch gun lever. Segregated ferrite on edge of test piece. Slag inclusions.

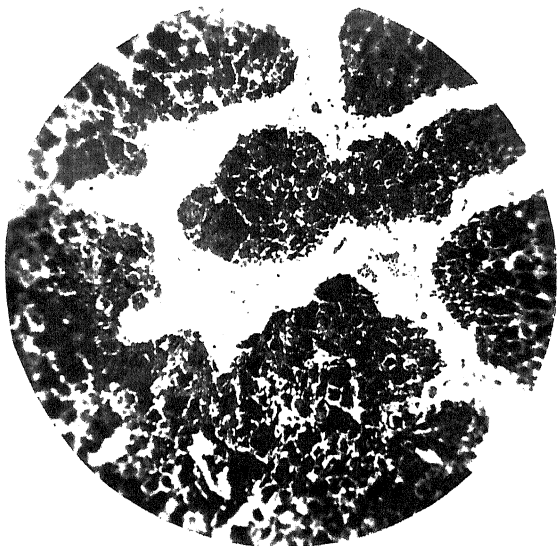
PHOTOGRAPH NO. 48. X50.

Fourteen-inch gun lever. Segregated ferrite (white) with slag inclusions.

In the fractured ends of the test pieces the metal shows decidedly bright spots, and these are due, it is believed, to the presence of the segregated ferrite. Further, it has been noticed that along the stem of the test pieces incipient cracks are developed, as shown in photograph No. 45. It is highly probable that these incipient fractures are developed in such areas as shown in photograph No. 47, which shows a large ferrite field at the edge of the specimen. It is possible that if the forces are transmitted equally throughout the test piece that such a portion would yield more readily where the carbon was lowest. The strength of such a spot would be approximately that of pure iron, or about 40,000 pounds per square inch, while the darker areas which contain more carbon would show considerably higher values. The presence of much slag in the ferrite areas would also increase the brittleness at this point, and would account for the low ductility in some specimens. Further examples of this form of segregation are shown in photographs Nos. 48 and 49.

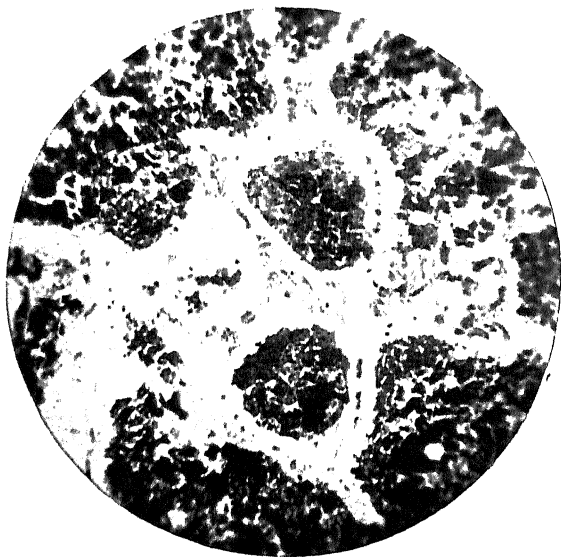
PHOTOGRAPH NO. 49. X50.

Fourteen-inch gun lever. Segregated ferrite with slag inclusions.

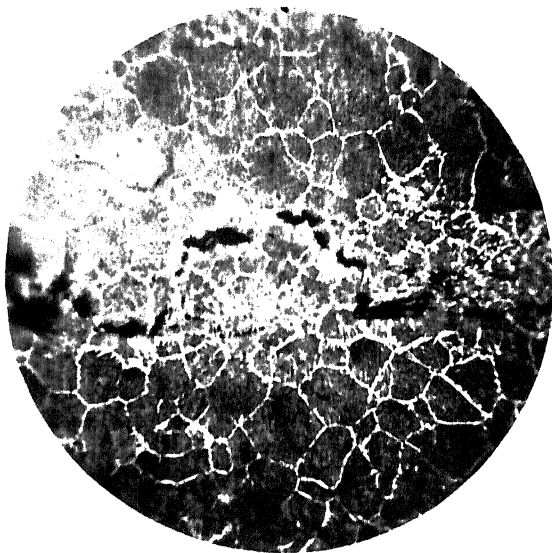
PHOTOGRAPH NO. 53. X50.

Twelve-inch gun. Microstructure showing slag and fissures.

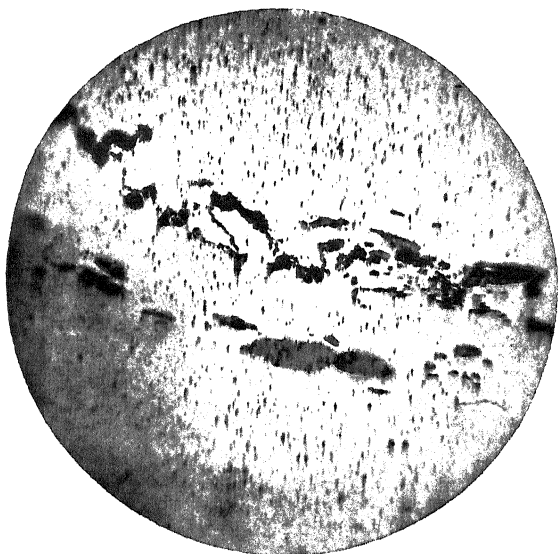
PHOTOGRAPH NO. 54. X50.

Twelve-inch gun. Slag in unetched specimen.
